BLAST FURNACE NO.5
TATA STEEL LIMITED,
PORT TALBOT, UK

Blow-in of Tata Steel's Port Talbot No.5 blast furnace took place on 19th January 2019 after a short campaign extension.

PROJECT HIGHLIGHTS

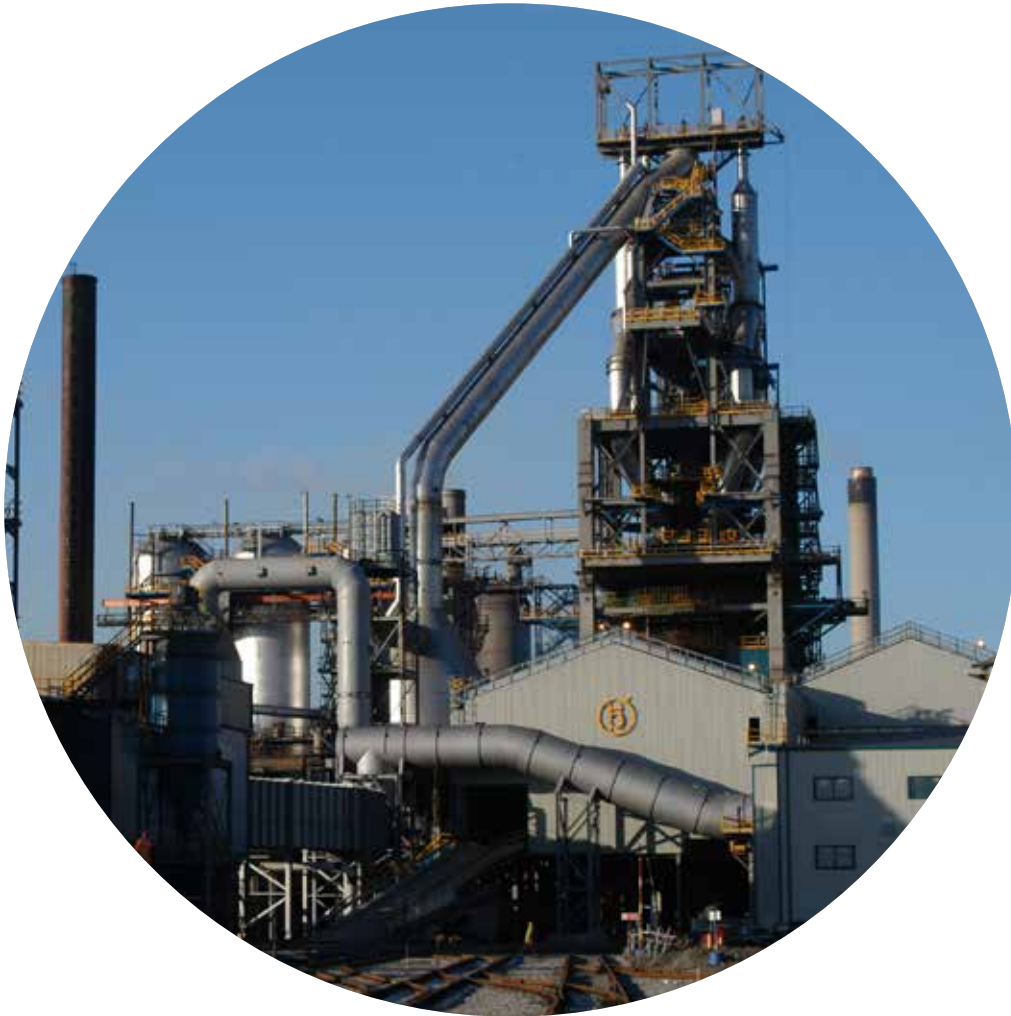
1. Downcomer
2. Furnace shell
3. Hearth refractory

The downcomer was highlighted as a critical area due to concerns over the internal refractory and shell condition. A further complication was that a large section of semi-clean

The belly area of the furnace was identified as a critical area as wearing refractory had caused premature ageing of the shell in this location. As a result, a band in the belly area of the furnace was removed and replaced with new, including new refractories.

The hearth pad was identified as a critical area due to significant wear being identified from the embedded thermocouples. A partial repair of the hearth area was carried out at the tapholes and the base of the hearth. This included the replacement of the embedded thermocouples and the external cooling system.
